TEST REPORT

Rep. No. : 11-11-VAA-106E
Applicant : DynaColor, Inc.
Address : No.116, Jou Tz Street, Neihu, Taipei 114, Taiwan
Commodity : IR Bullet IP Camera Housing
Model : Main Model : NV053
Series Model : X₁X₂05X₃(Consult Page 2)
Quantity : 2 sets
Date of Receipt : Nov. 23, 2011
Date of Testing : Nov. 26, 2011
Test specification : IEC60529 Edition 2:1989 + Amendment 1:1999
Ambient Environment : Temp. 21 °C, R.H. 68 %, A.P. 970 mbar
Test Item : IP67
Test condition & result : See the following sheets

1. Test Item : IP67**2. Test Conditions :****2.1 Ambient Condition**

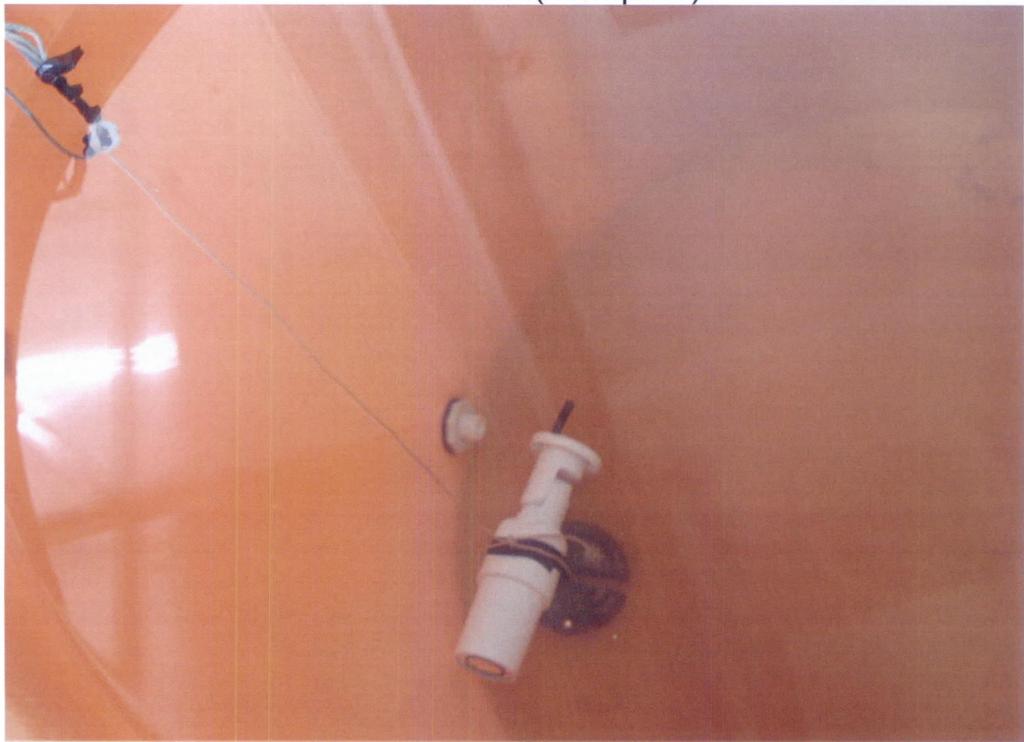
IPX7 Test(Sample1)

2.2 IPX7 (In accordance with IEC60529 14.1/14.2.7 test)

- Water depth:1000 mm above the specimen.
- The duration of the test is 30 min.
- The water temperature does not differ from that of the equipment by more than 5 K.

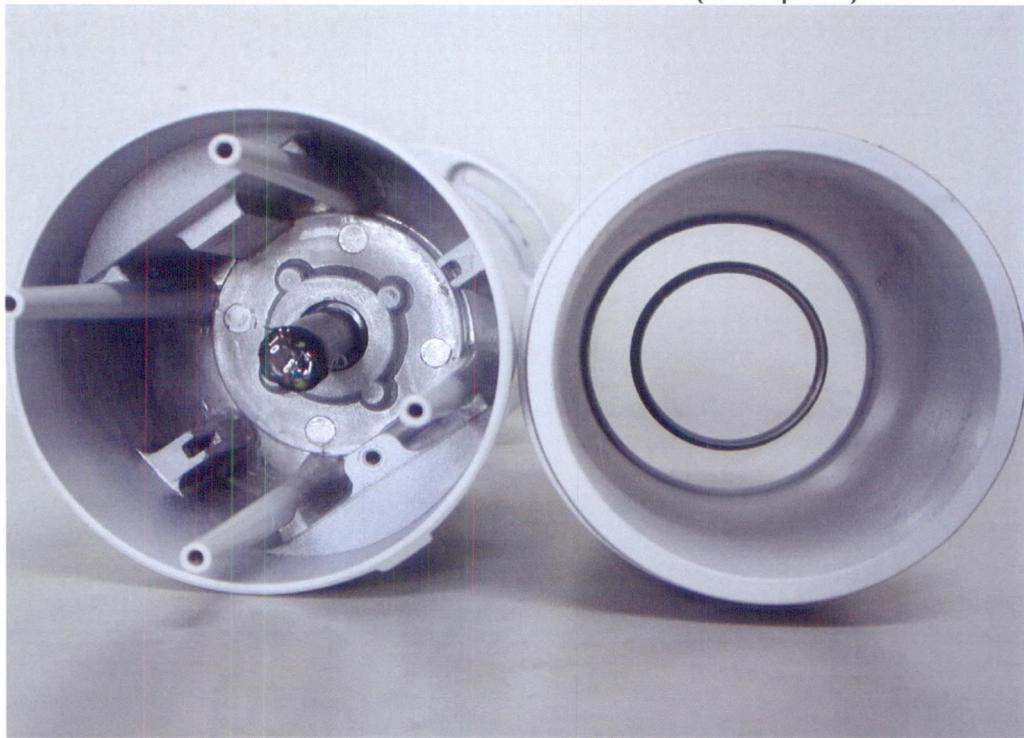
There is no trace of water inside.(Sample1)

IP Code	Results	Acceptance Criteria
IPX7	There is no trace of water inside.	IEC60529 14.3
IP6X	There is no trace of dust inside.	IEC60529 13.6

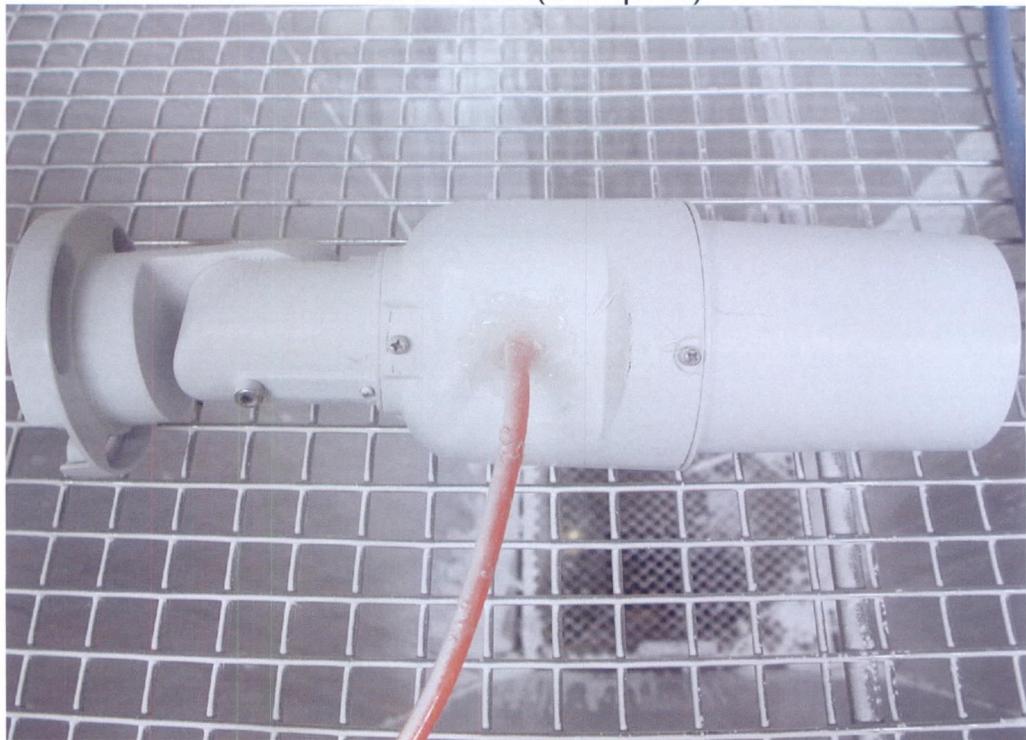
IP6X Test(Sample1)

2.3 IP6X (In accordance with IEC60529 13.4 test)

- Dust:Talcum powder.
- The amount of dust:2 kg/m³.
- Maximum depression of 2kPa.(20mbar).
- The duration of the test is 2 hr.

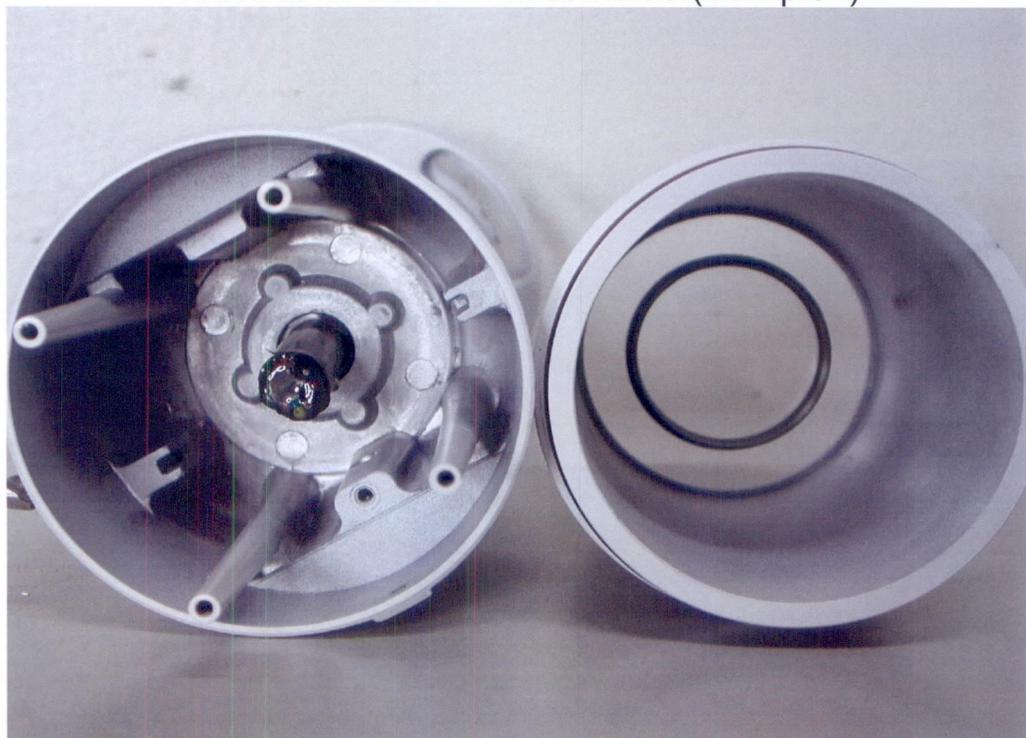
There is no trace of dust inside.(Sample1)

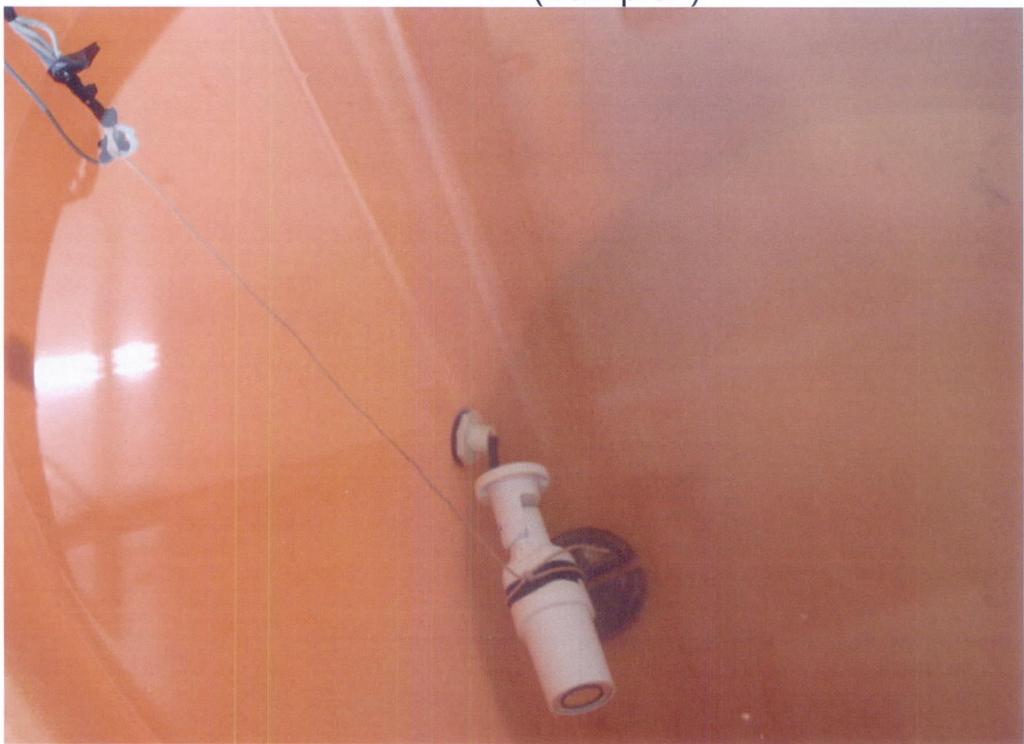
IPX7 Test(Sample2)

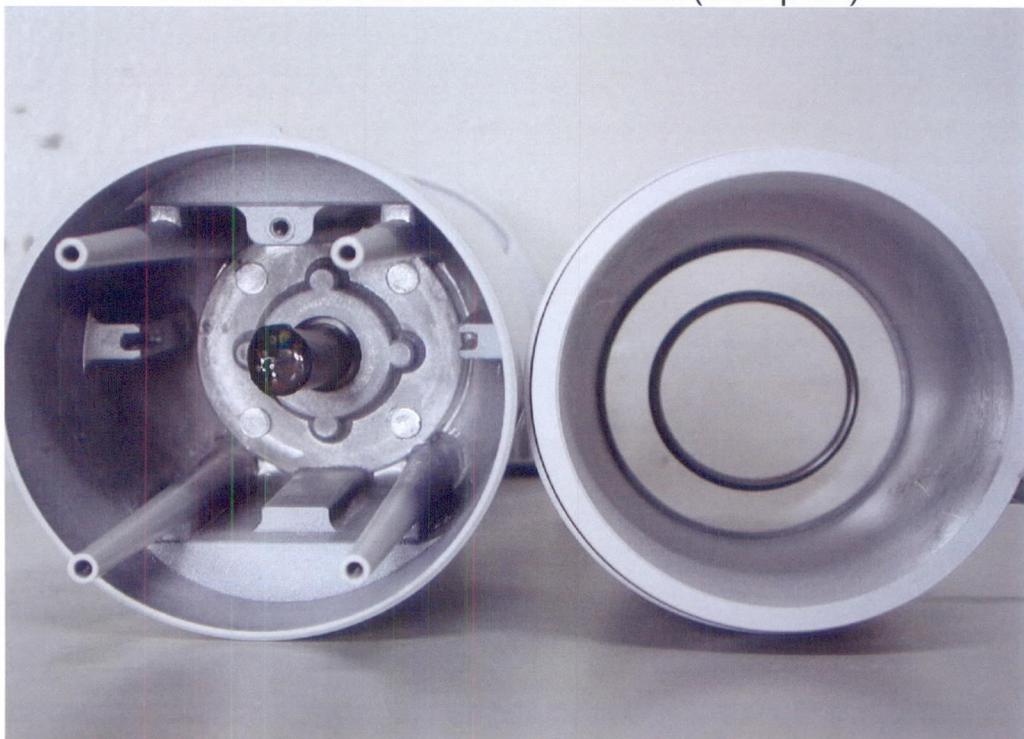
There is no trace of water inside.(Sample2)

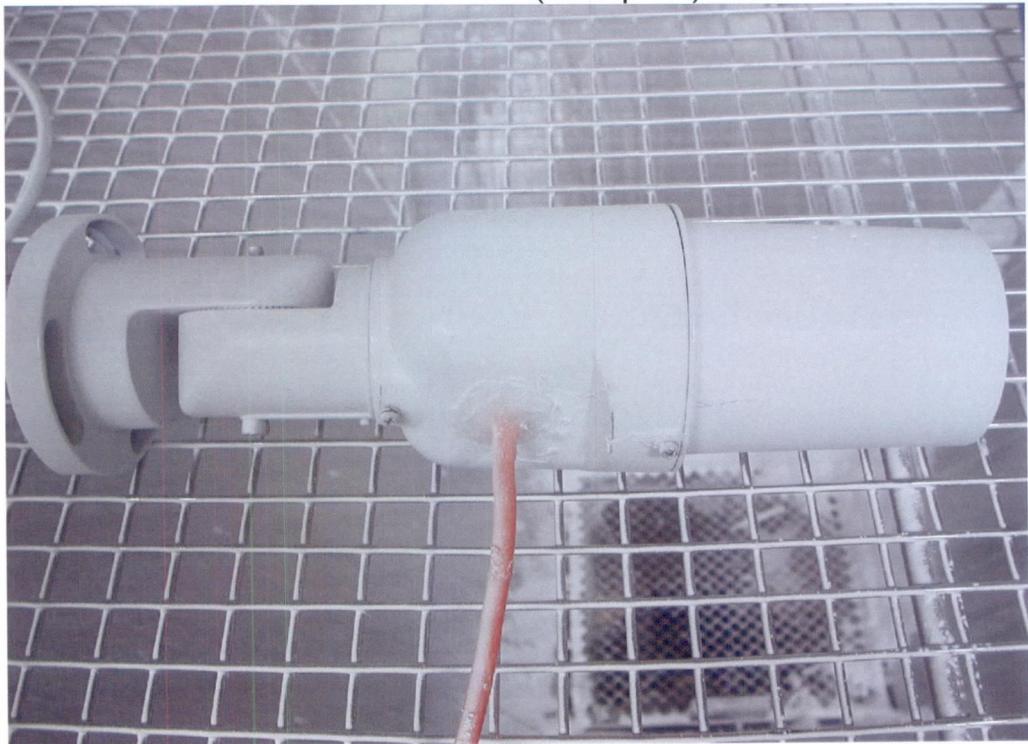
IP6X Test(Sample2)
